Manhole Inspection Summary

Manhole # **S15CC_015MH**

Insp Date: **11/5/07 10:48 AM**

Location Address: **REAR 1101 ASHBURTON**

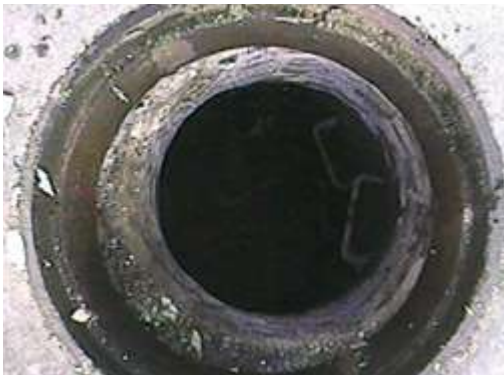
Defect 1

Offset: **4** (in.)

FRAME OFFSET

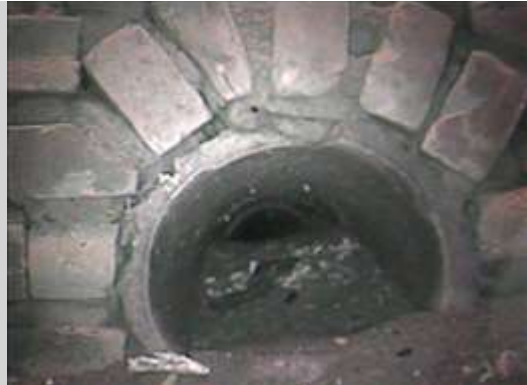
12 O'Clock Outflow

8 in. Circular Gravity Sewer
Pipe Out @ 12 O'Clock

Deposits: ☐ None ☐ Mud ☐ Sludge ☒ **Debris** ☐ Grease

Silt Depth: **2** (in.) Deposits Extent: **Medium**
